U.S. Customs and Border Protection Office of Air and Marine

Aircraft Mishap Report

Asset: General Atomics MQ-9 Guardian

Asset Number: CBP159

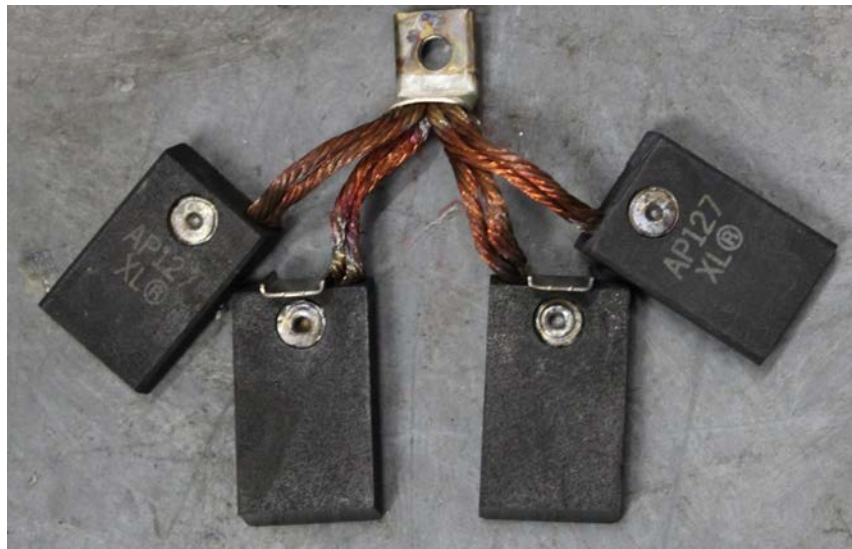
The starter/generator utilizes 16 individual carbon brushes. The brushes are arranged in 4 assemblies of 4 brushes each and are positioned at the 12, 3, 6, and 9 o'clock positions around the commutator. Each brush in the assembly is attached to a common contact point by a braided copper wire that is fastened to the brush by a single copper rivet.

Figure 1. An intact single rivet brush assembly

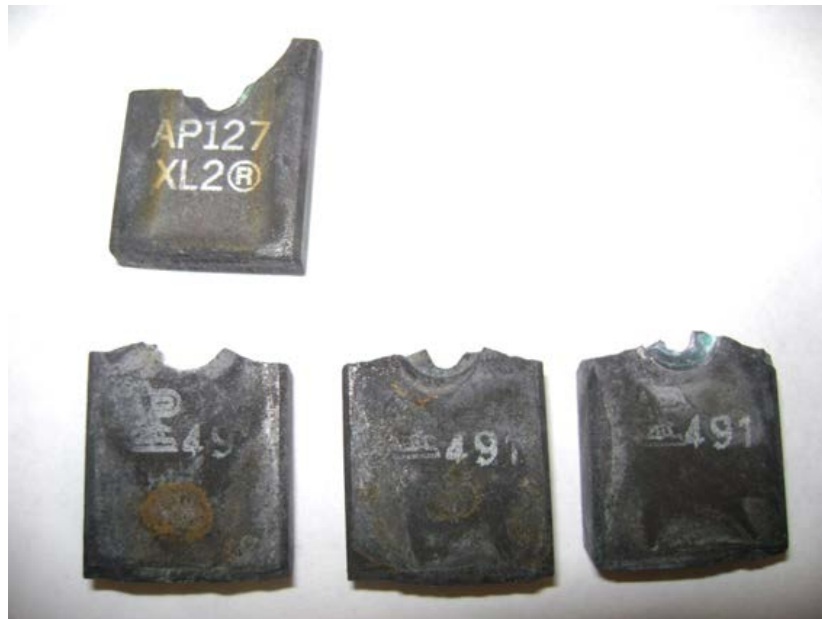
Carbon brushes are fragile and prone to breaking if subjected to excessive heat, vibration, uneven pressure, and electrical arcing. All of the brushes in CBP159's starter generator were excessively worn, likely caused by uneven contact with the commutator. Many of the brushes were broken, with the break line running through the rivet hole. Single-rivet design brush assemblies have displayed a weak point around the rivet. Arcing and excessive heat cause the rivet to loosen. Once loose, the rivet causes cracks in the brush material it comes in contact with, leading to eventual breakage. An intact single rivet brush assembly that was not removed from CBP159 is shown above (Figure 1). The picture clearly shows discoloration and evidence of arcing on the rivet heads.

The actual brushes removed from CBP159 are shown below (Figure 2). The picture shows the break that runs through the rivet hole as well as the uneven wear and missing material on the bottom of the brush. The brush assemblies are not made by Skurka Aerospace. General Atomics engineers also noted design and minor quality control deficiencies with the brush manufacturer in their investigation and addressed those issues directly.

Figure 2. Brushes from CBP159's starter/generator

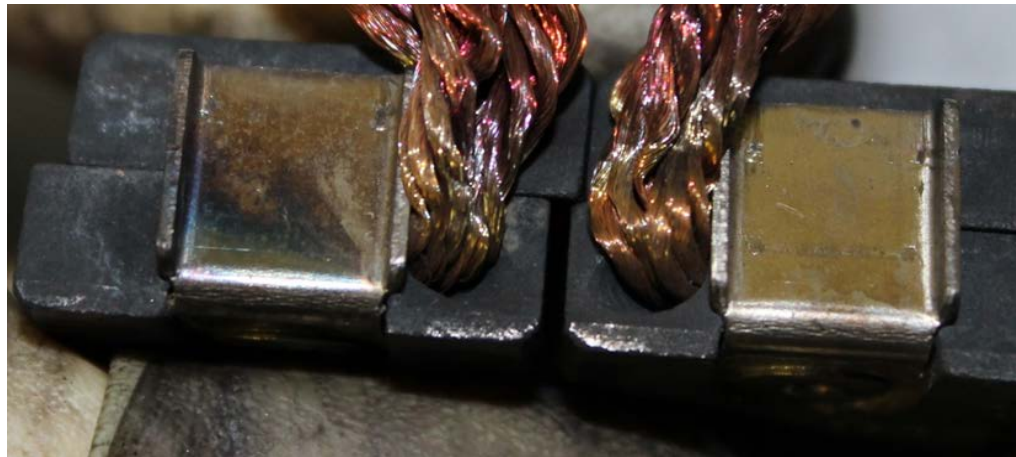
When the brush assemblies are installed in the starter generator, the four brushes are aligned in pairs in their holders. Constant down pressure is required to maintain proper contact with the commutator to keep the brushes from moving and to prevent electrical arcing. The spring guides are the contact point where the spring rests that provides the alignment of the springs and the brushes. If the spring guide fails, uneven pressure causes

one brush to wear more than the other which creates a gap. Arcing occurs in the gap and the brush is free to move in its guide, and the brush eventually breaks.

The spring guide is a flat piece of copper that is bent 90 degrees and is attached to each of the brushes by a single rivet (Figure 3). The bend permits the end of the guide to overlap the other brush in the assembly. General Atomics engineers found that the bend radius is too tight, which causes a weak point in the metal. Very small stress cracks develop over time. The rate and severity of the cracks depend on how much excessive heat the part has been subjected to. Heat in that area weakens the bend area until it fails. Once the spring guide fails, the spring makes contact with the brush, causing damage, and constant down pressure is lost. CBP159's starter/generator had four of its eight spring guides broken.

Figure 3. Spring guides

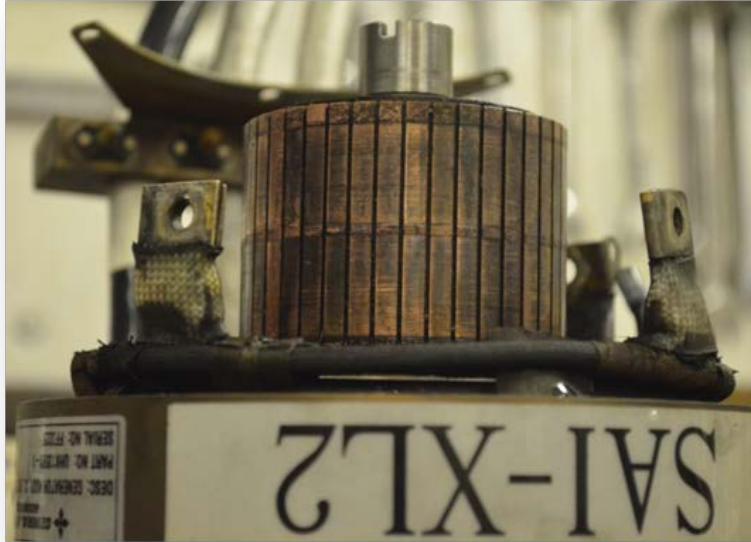
Two of the commutator bars on CBP159's starter generator were found to be raised .004 inch and .007 inch above the rest. They were positioned exactly 180 degrees opposite each other. Once a bar becomes raised it causes excessive wear to the brushes every time it passes one. Again, this leads to uneven brush wear that has the same result as encountered with a broken spring guide. As the brush is worn down, arcing increases, and the commutator has the tendency to deteriorate the most from the excessive heat build-up. CBP159's commutator is one of the only examples intact enough to be examined. In past examinations, the majority of commutators are found with the bars melted together or burnt beyond recognition.

Figure 4. Commutator

The two potential causes of the raised bars are excessive heat build-up that loosened the bars or what is known as “magnetic sticking” during the start sequence. For this to occur, the bar would have had to come to a stop directly under a brush after the previous shutdown. When the starter is actuated the magnetic field builds rapidly to turn the starter generator. The starter must carry a load of 500 amps in order to overcome the torque of turning the cold engine. If the bar was directly underneath a brush, the magnetic stress could potentially pull the bar out of place. If the commutator was still hot from previous operation or the bars were already loosened by heat, the magnetic forces would have a greater effect.

At the time of this report, General Atomics is investigating the manufacturer of the commutator, conducting hardness testing on CBP159’s commutator, and conducting research on the start sequence.

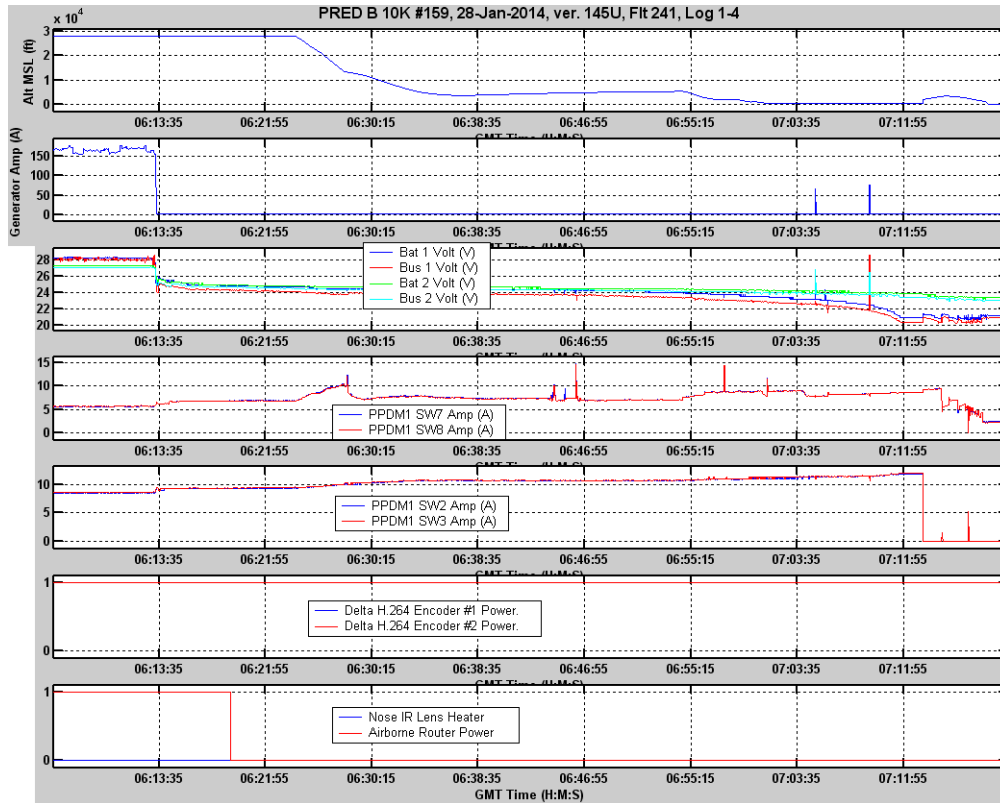
Figure 1 identifies failure of the aircraft power generation system and resultant operation on the emergency battery backup power supply.

Note: Bus 1 operation maintains the highest load throughout the failure, and is the first to exhaust, resultant in SATCOM link interruption about time 07:11:55.

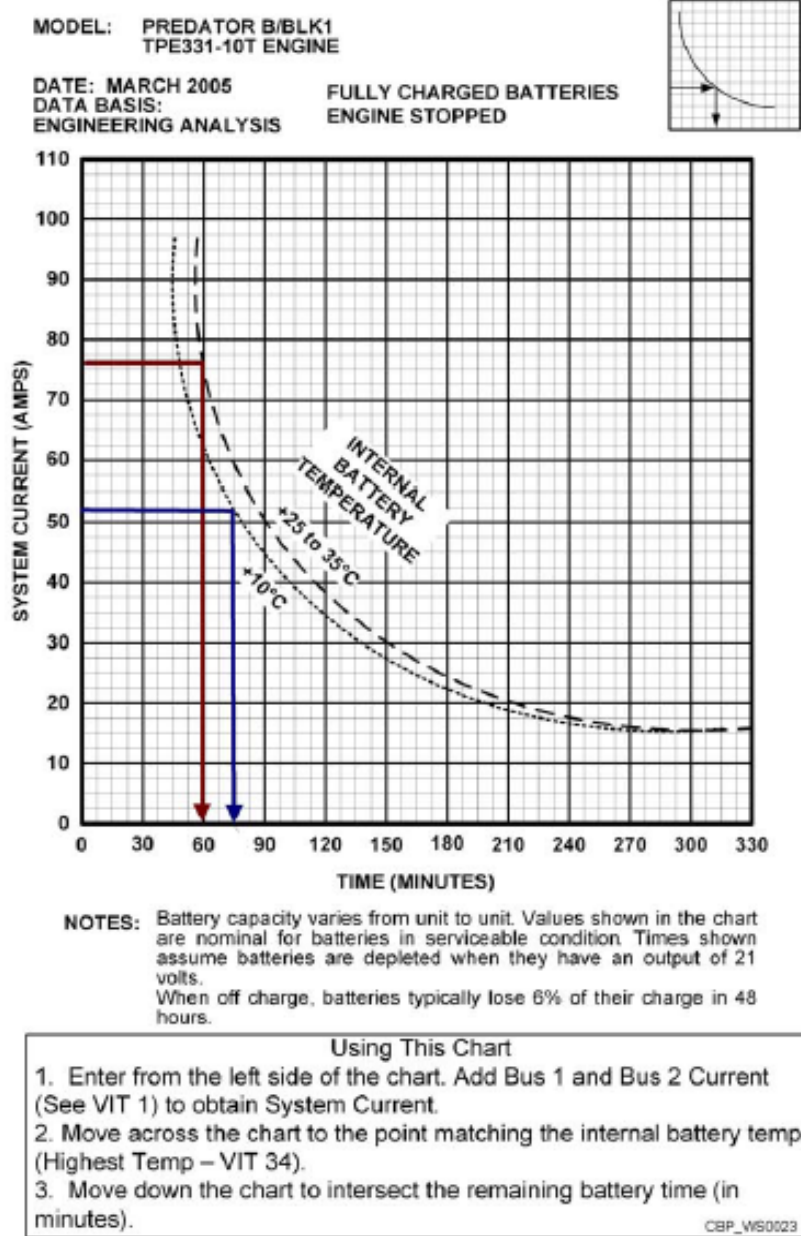
Figure 2 – Battery duration chart
